INDOOR AIR QUALITY ASSESSMENT

Chicopee City Hall 17 Springfield St Chicopee, Massachusetts

Prepared by:
Massachusetts Department of Public Health
Center for Environmental Health
Emergency Response/Indoor Air Quality Program
April 2007

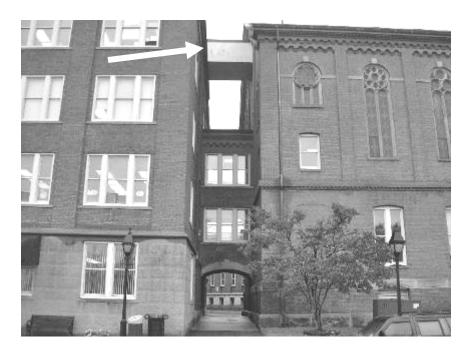
Picture 2

Elevated Walkways, Note HVAC Vent Ductwork above the Uppermost Walkway (Arrow)

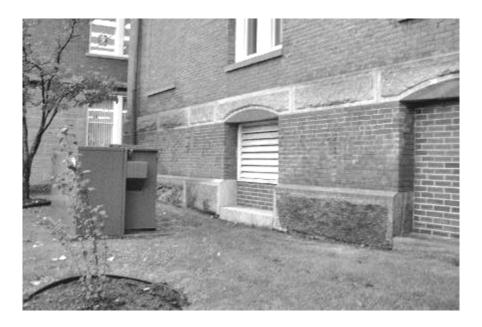
Picture 4

Several other conditions that can affect indoor air quality were noted during the assessment. Of note is the location of the fresh air supply vent for the 1872 building near ground level on Front Street (Picture 4). In this configuration, idling vehicles can produce vehicle exhaust that can be drawn into the CCH. M.G.L. chapter 90 section 16A prohibits the unnecessary operation of the engine of a motor vehicle for a foreseeable time in excess of five minutes (MGL, 1986).

Fresh Air Supply, 1872 Wing

- 6. Consider prohibiting parking in the general areas of AHU air intakes to minimize/prevent vehicle exhaust entrainment. If not, feasible consider posting signs instructing occupants/visitors not to back into parking spots and to cease idling after 5 minutes as per M.G.L. chapter 90 section 16A.

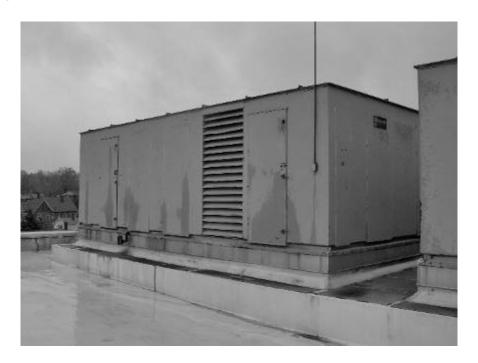
Picture 5

1929 Rooftop AHU
